Freescale Semiconductor
Reference Manual Addendum

MCF5485RMAD
Rev. 5, 4/2009

MCF5485 Reference Manual Errata

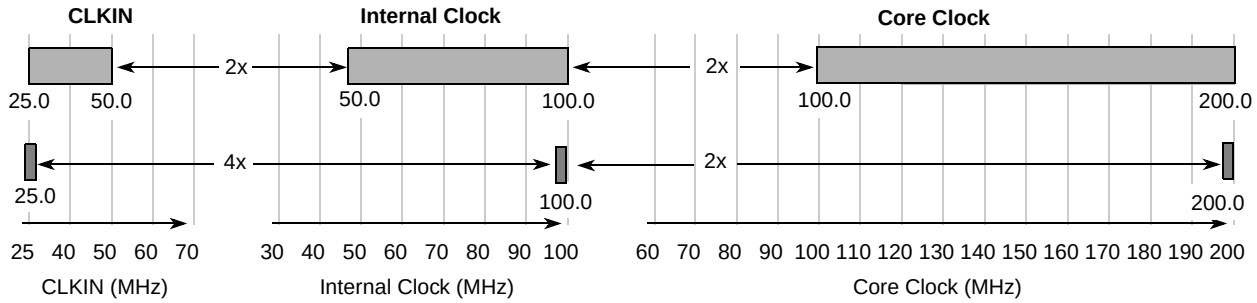
Location	Description
Section 2.2.6.1/Page 2-24	Add the following after Table 2-4: Figure 1 correlates CLKIN, internal bus, and core clock frequencies for the 1x–4x multipliers.

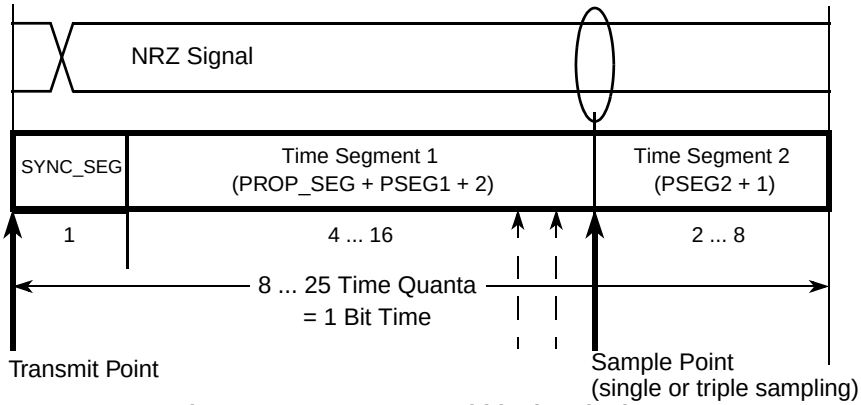
Figure 21-14. Segments within the Bit Time

Table 16-1/Page 16-2	Extend SSCR entry to include bytes 2 & 3 as well as bytes 0 and 1, since it is a 32 bit register.
Section 17.6.5.4.2/Page 17-26	Change “transfer start” to “address latch enable” in second sentence.
Section 21.4.9/Page 21-30	Figure 21-14 and Table 21-18 are missing. Add them as shown below and correct the cross-references to them.
